Comments on Lower Colorado River Authority Fayette Power Project Draft Report

Assessment of Dam Safety of Coal Combustion Surface Impoundments

Sam Seymour - Fayette Power Project Station

Draft Report

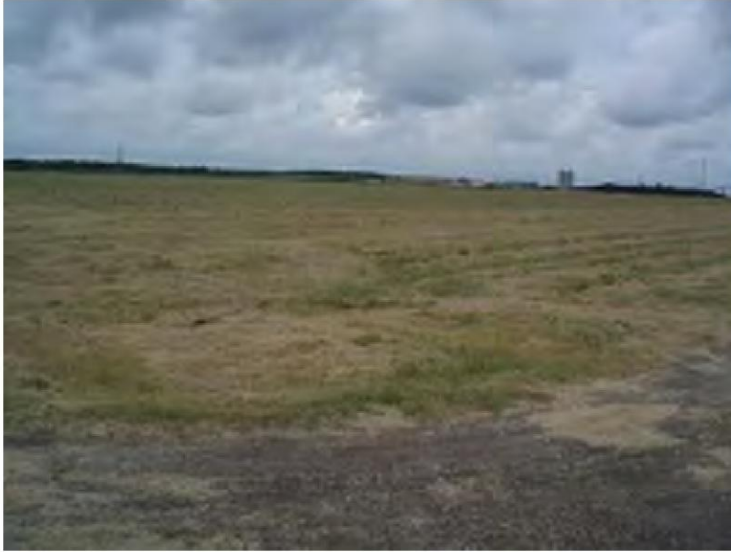
Photo No. 105: CADP – Overview of capped portion of impoundment from northeast corner, looking southwest.
